## Fan Bearing Maintenance & Troubleshooting

## Bearing Failures and Their Causes

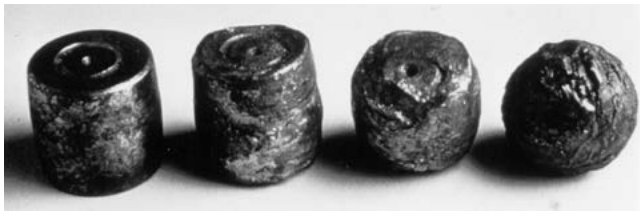
If the bearings continue to operate with inadequate lubrication, the evidence that shows this to be the mode of failure becomes destroyed. Notice how the spherical bearing rollers shown in Figure 9 become damaged with continued operation.

Figure 9. Damaged Spherical Bearing Rollers

If the bearing had been taken out of operation when the roller was in the condition shown on the left, it would be possible to determine the cause of failure. By the time the bearing completely failed, it had run so hot that the steel softened and the bearing became deformed. At this point it is impossible to tell what caused the initial failure. If you are having unexplained bearing failures, it is best to take the bearing out of service when you first notice noisy, hot or vibrating operation. The evidence showing the initial cause of failure is probably still visible and it will give you an idea as to what action to take to prevent additional failures.

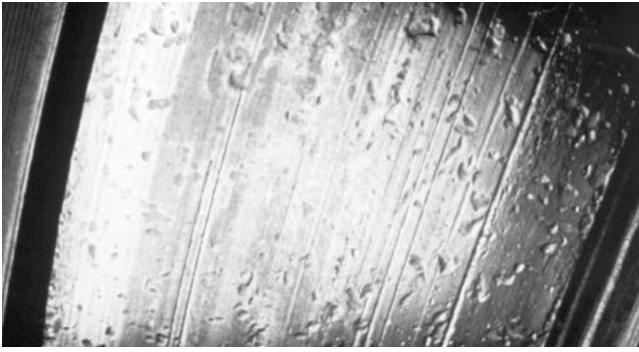
Material that flakes out of spalls and other contaminants from other sources such as dirty grease or worn seals dents the races when caught between the rollers and races. Figure 13 shows an inner race with severe particle denting. Figure 7 also shows signs of particle denting. Each dent is a stress concentrator, which increases the stress in the area around the dent and accelerates the fatigue failure process.

Figure 13. Severe Particle Denting
